RE: ASARCO East Helena Smelter, Transmittal of EPA Inspection
Report for Corrective Action Assessment Inspection, September 8, 2006

**U.S. EPA REGION VIII
TECHNICAL ENFORCEMENT PROGRAM
RCRA COMPLIANCE INSPECTION REPORT**

Facility: ASARCO East Helena Plant
100 Smelter Road
East Helena, MT

Inspection Type: Corrective Action Assessment Inspection

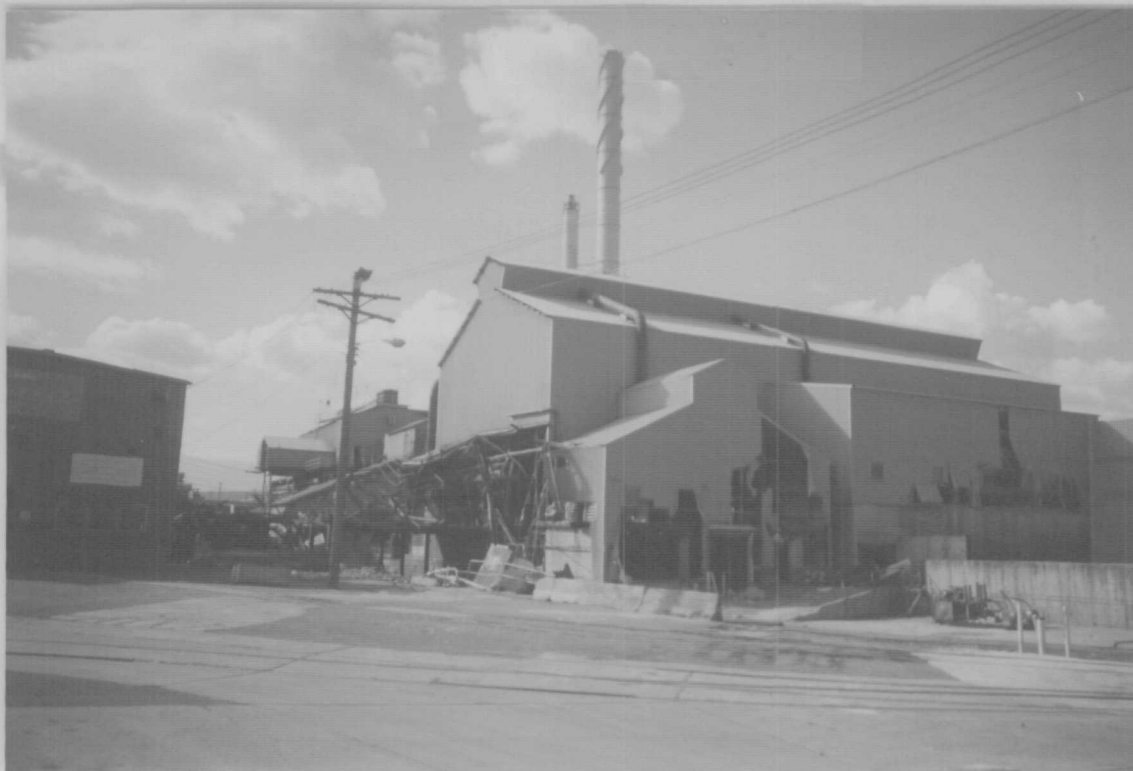
Roll 1, Photo 1; Facility: ASARCO East Helena Smelter; Subject: Dross Plant Demolition; Photographer: Linda Jacobson; Date: August 31, 2006

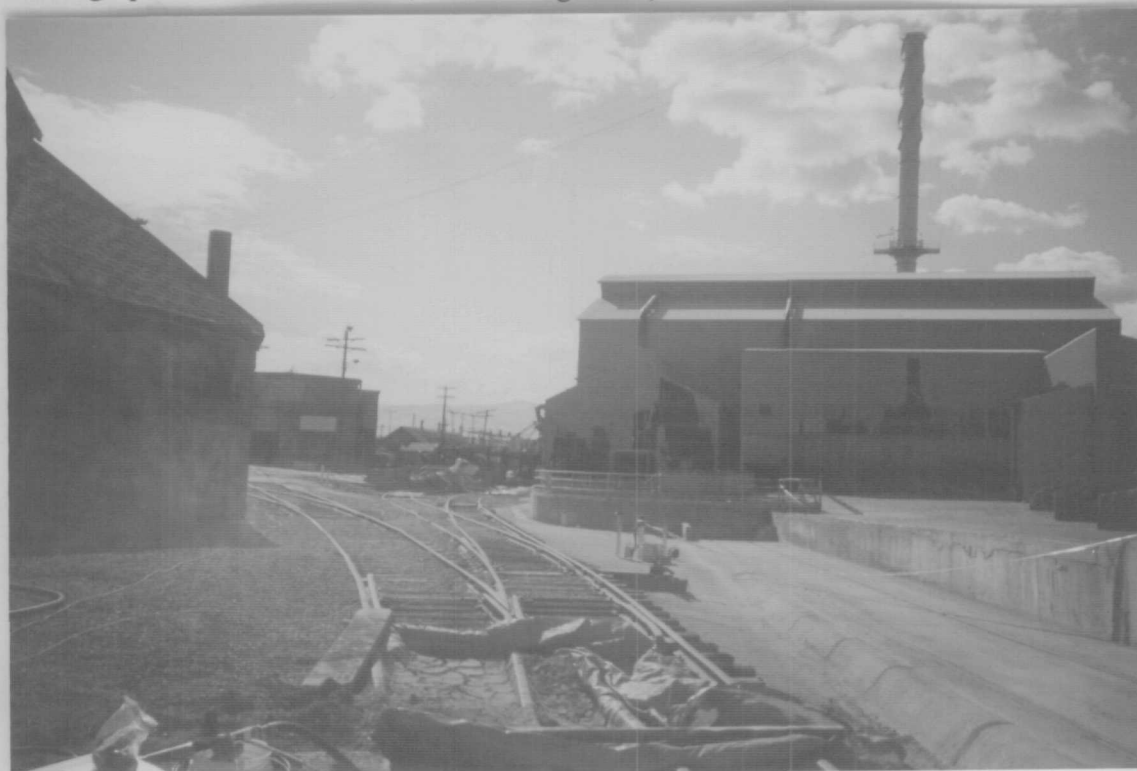
Roll 1, Photo 2; Facility: ASARCO East Helena Smelter; Subject: Dross Plant with Speiss Pit in Foreground; Photographer: Linda Jacobson; Date: August 31, 2006

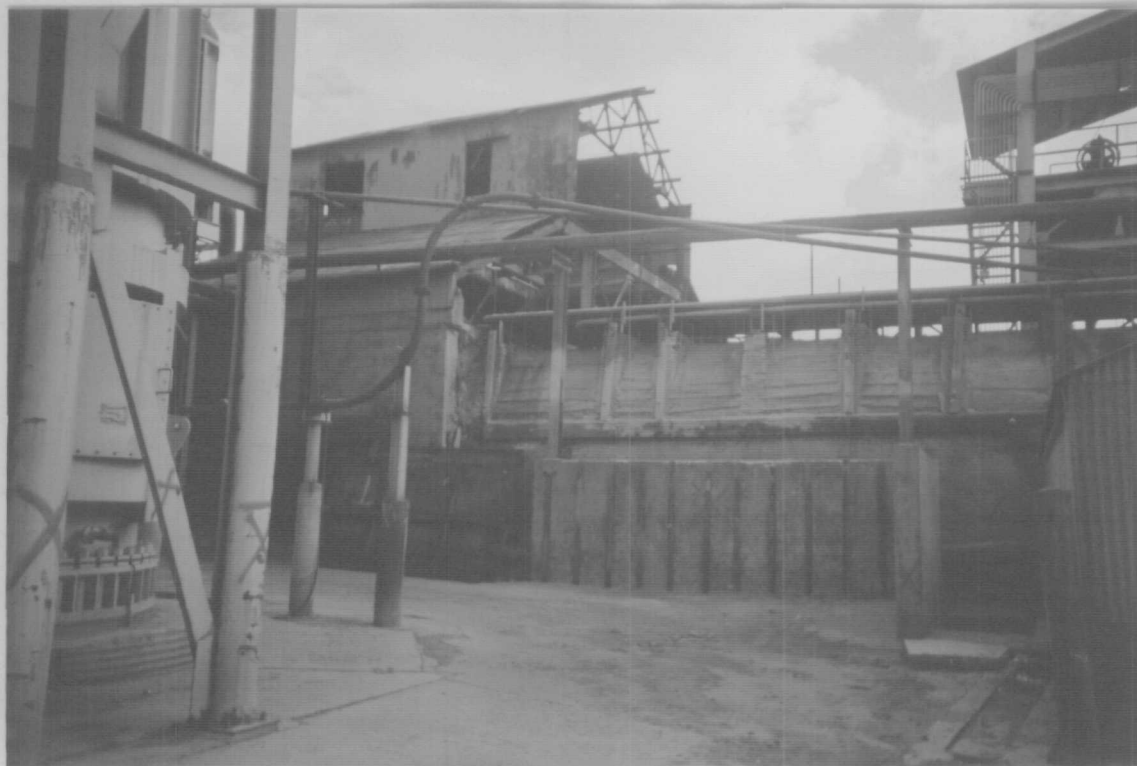
Roll 1, Photo 4; Facility: ASARCO East Helena Smelter; Subject: Dross Plant Baghouse Flue;
Photographer: Linda Jacobson; Date: August 31, 2006

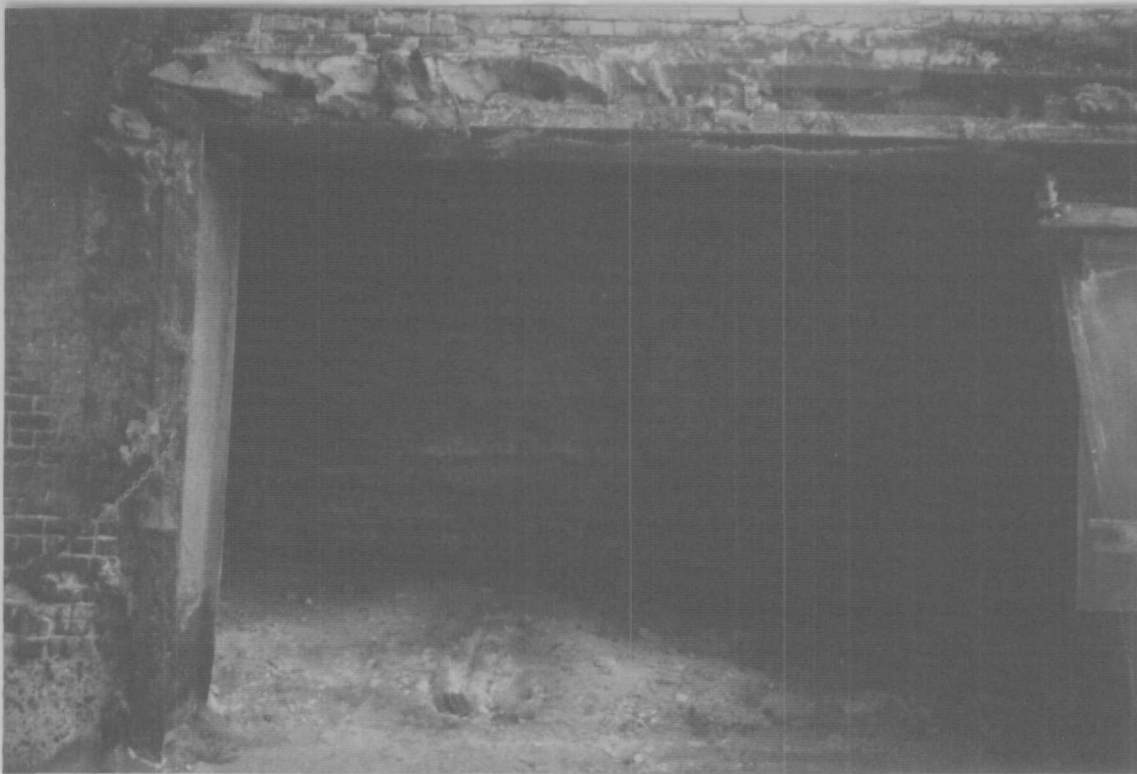
Roll 1, Photo 5; Facility: ASARCO East Helena Smelter; Subject: Inside of Dross Baghouse Flue; Photographer: Linda Jacobson; Date: August 31, 2006

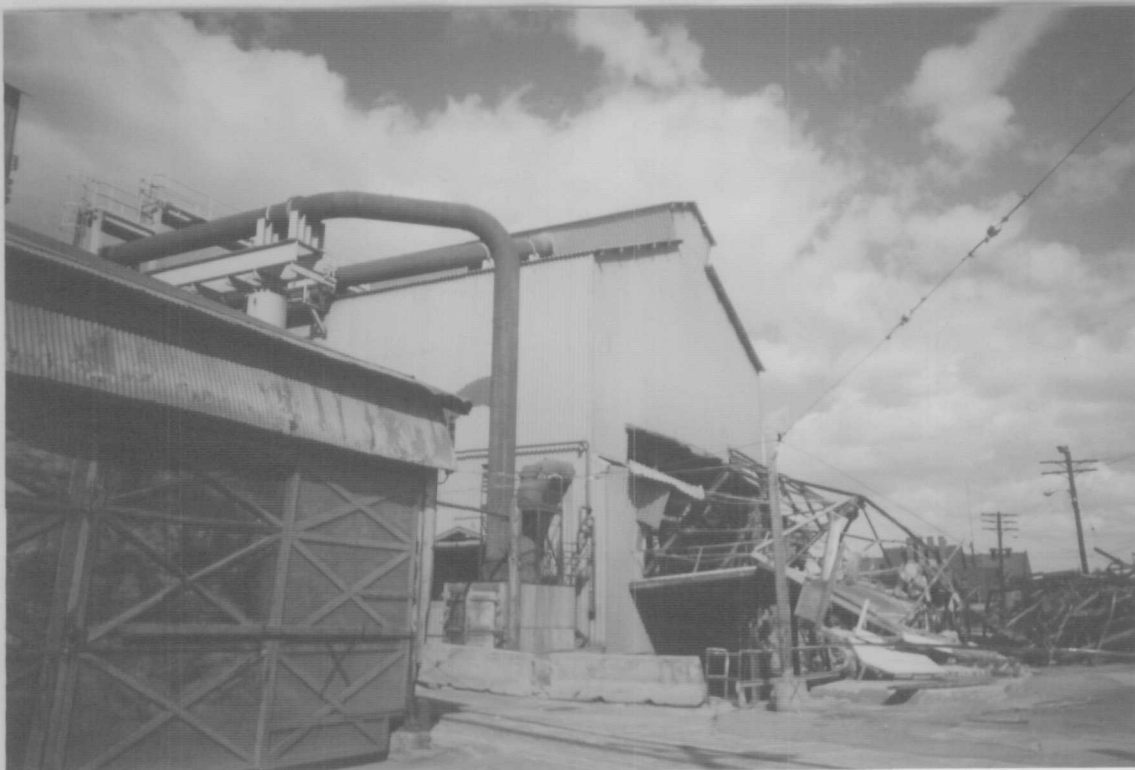
Roll 1, Photo 6; Facility: ASARCO East Helena Smelter; Subject: Dross Plant Demolition; Photographer: Linda Jacobson; Date: August 31, 2006

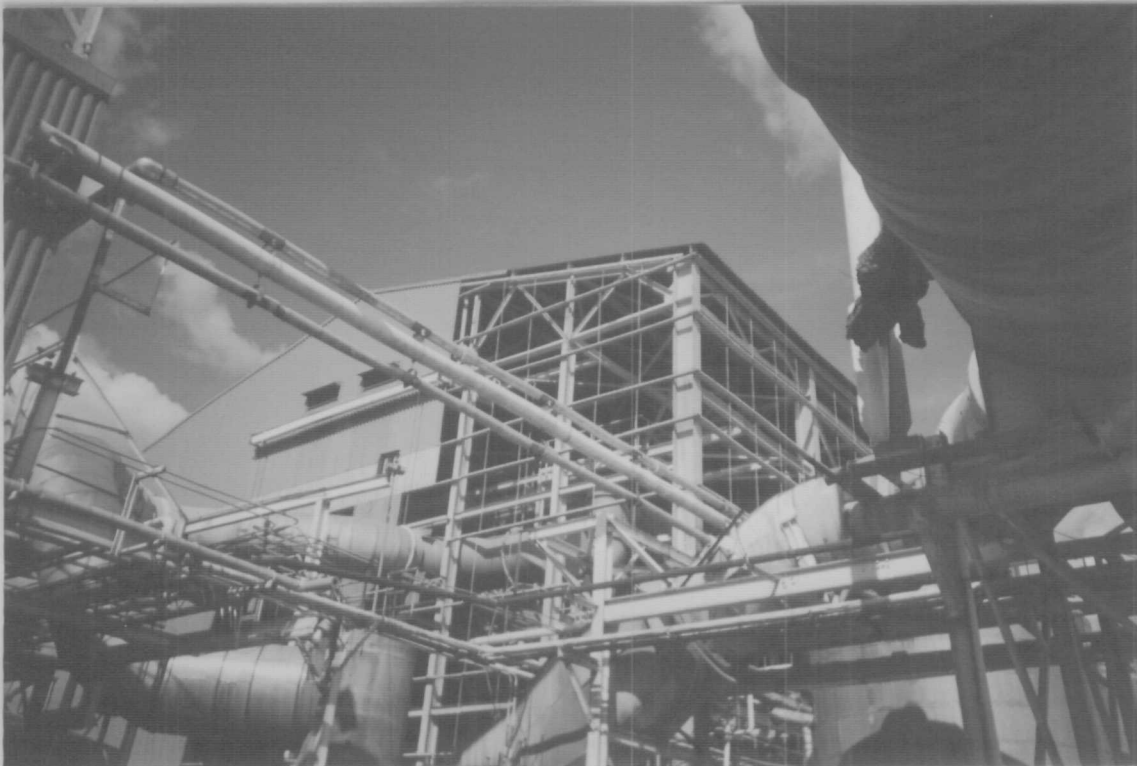
Roll 1, Photo 8; Facility: ASARCO East Helena Smelter; Subject: Structures to Be Demolished; Photographer: Linda Jacobson; Date: August 31, 2006

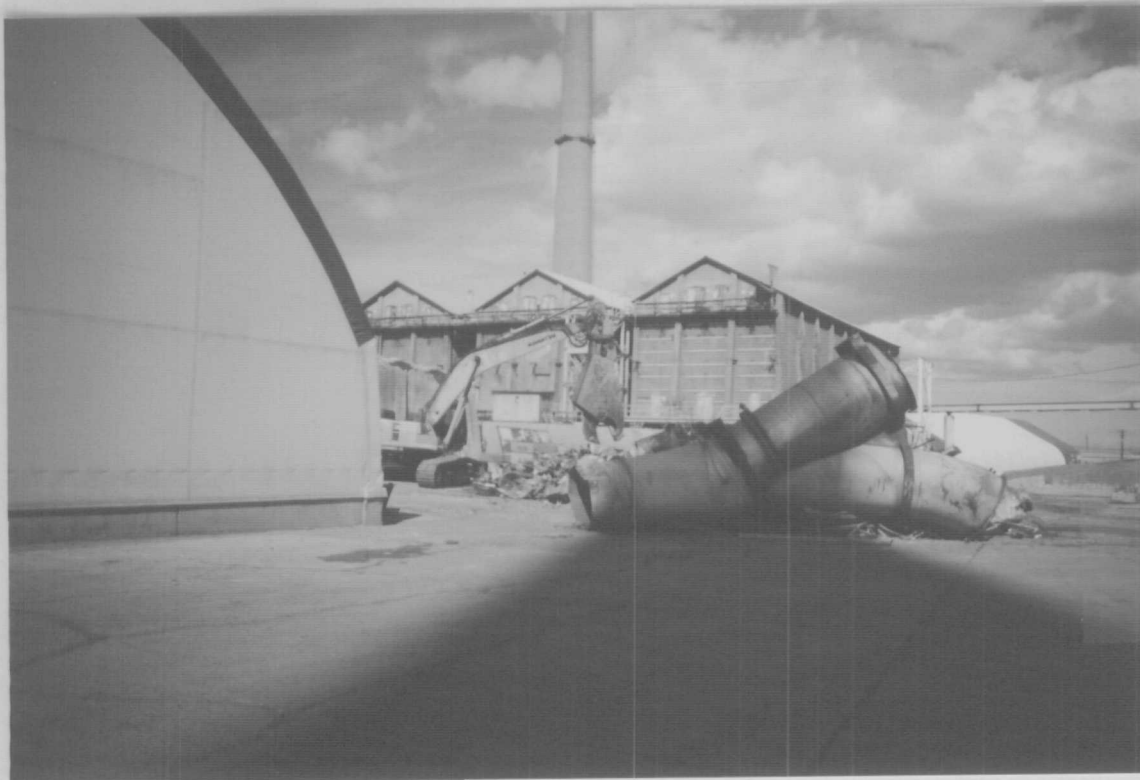
Roll 1, Photo 9; Facility: ASARCO East Helena Smelter; Subject: Outside of Bailey Building and Demolition Snippers; Photographer: Linda Jacobson; Date: August 31, 2006

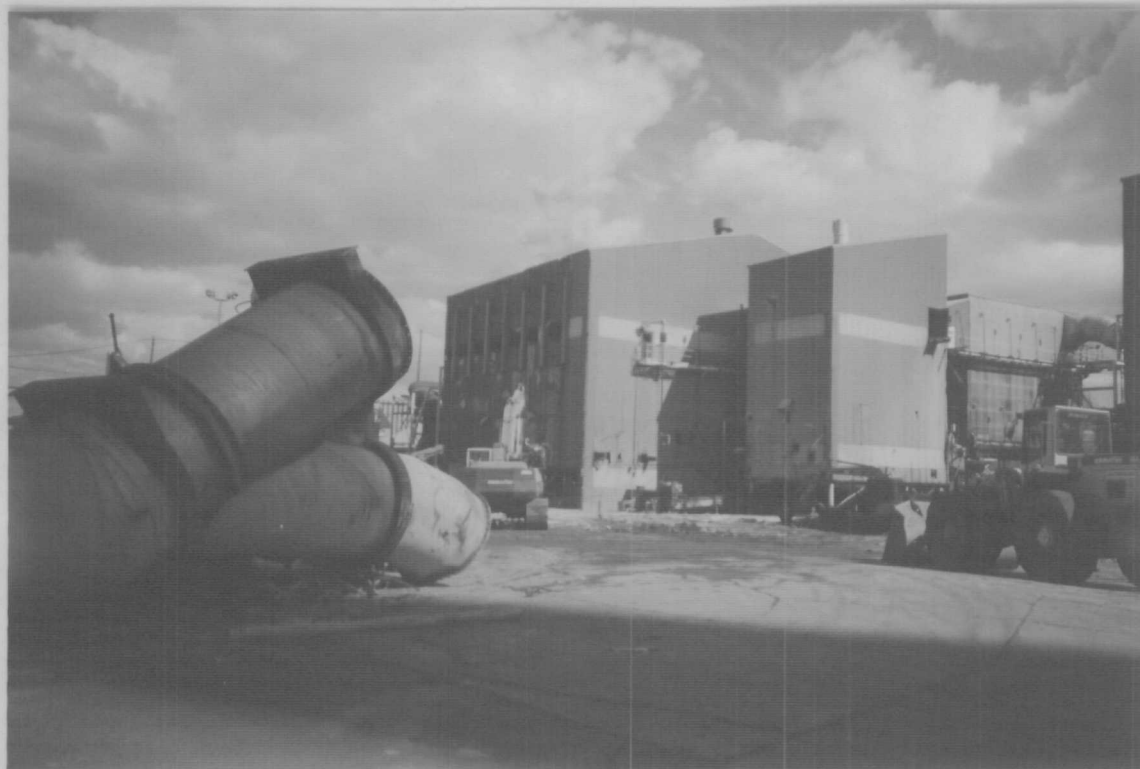
Roll 1, Photo 10; Facility: ASARCO East Helena Smelter; Subject: Hot Cottrell & Mist Precip. Buildings; Photographer: Linda Jacobson; Date: August 31, 2006

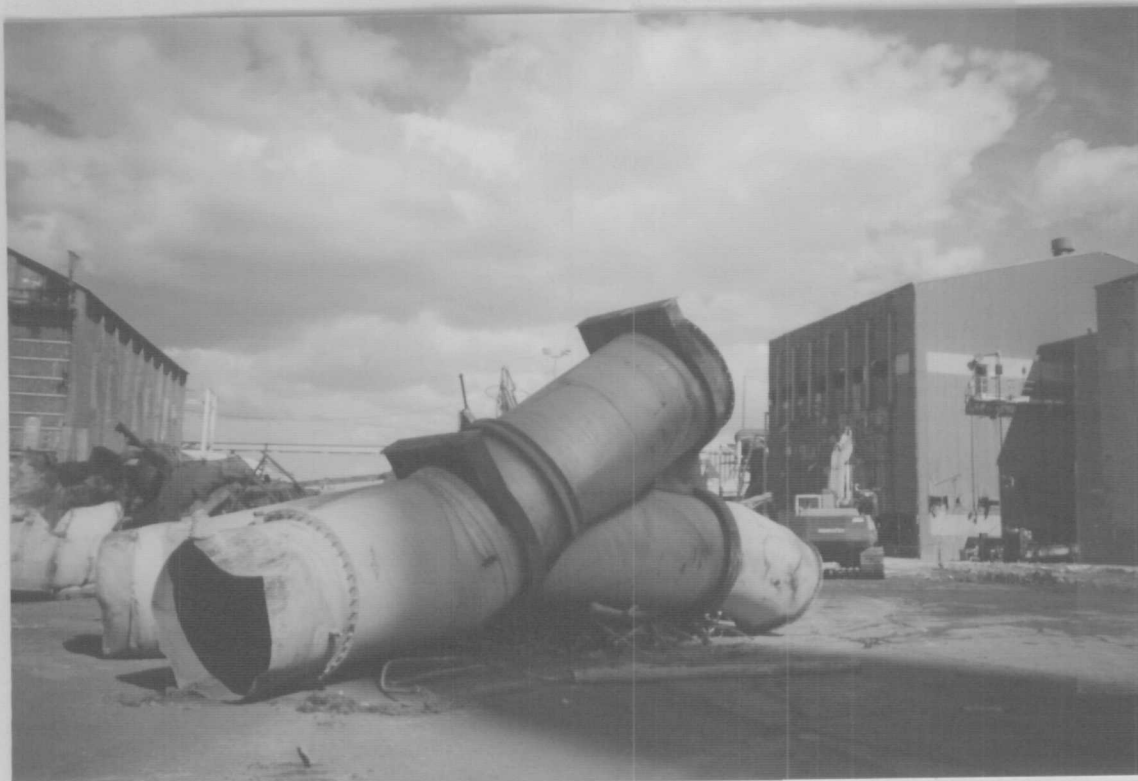
Roll 1, Photo 11; Facility: ASARCO East Helena Smelter; Subject: Hot Cottrell Building & Piping; Photographer: Linda Jacobson; Date: August 31, 2006

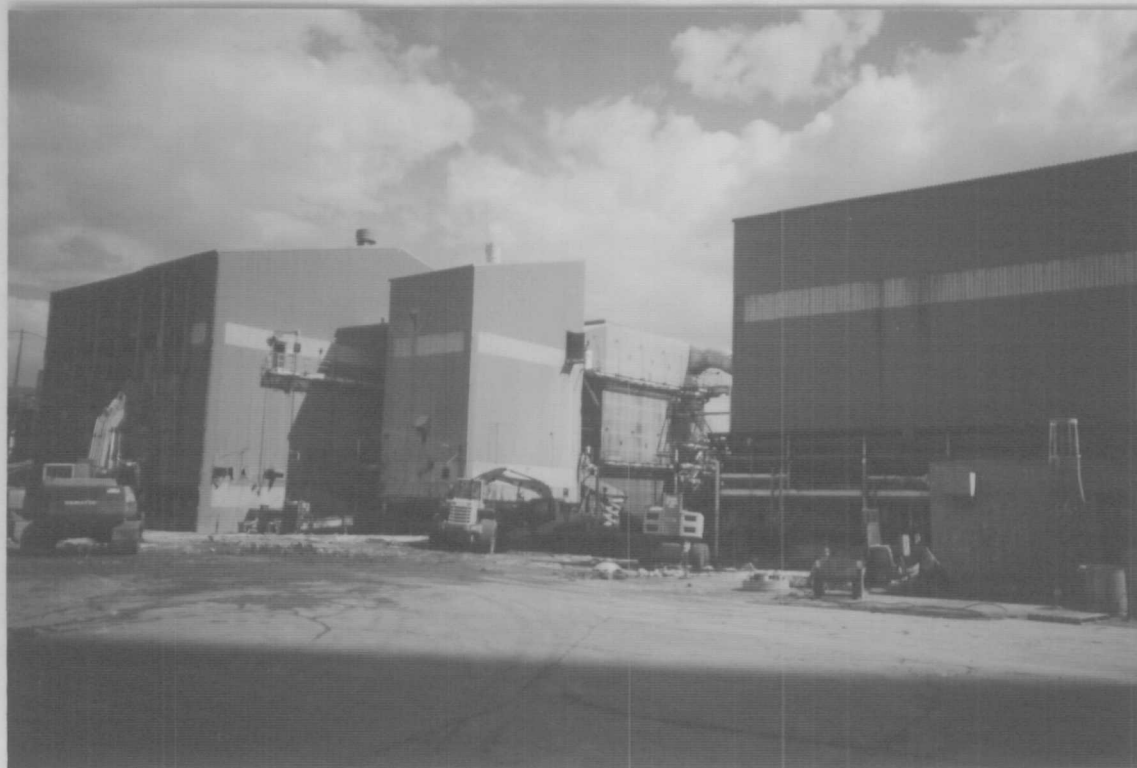
Roll 1, Photo 12; Facility: ASARCO East Helena Smelter; Subject: Hot Cottrell Building; Photographer: Linda Jacobson; Date: August 31, 2006

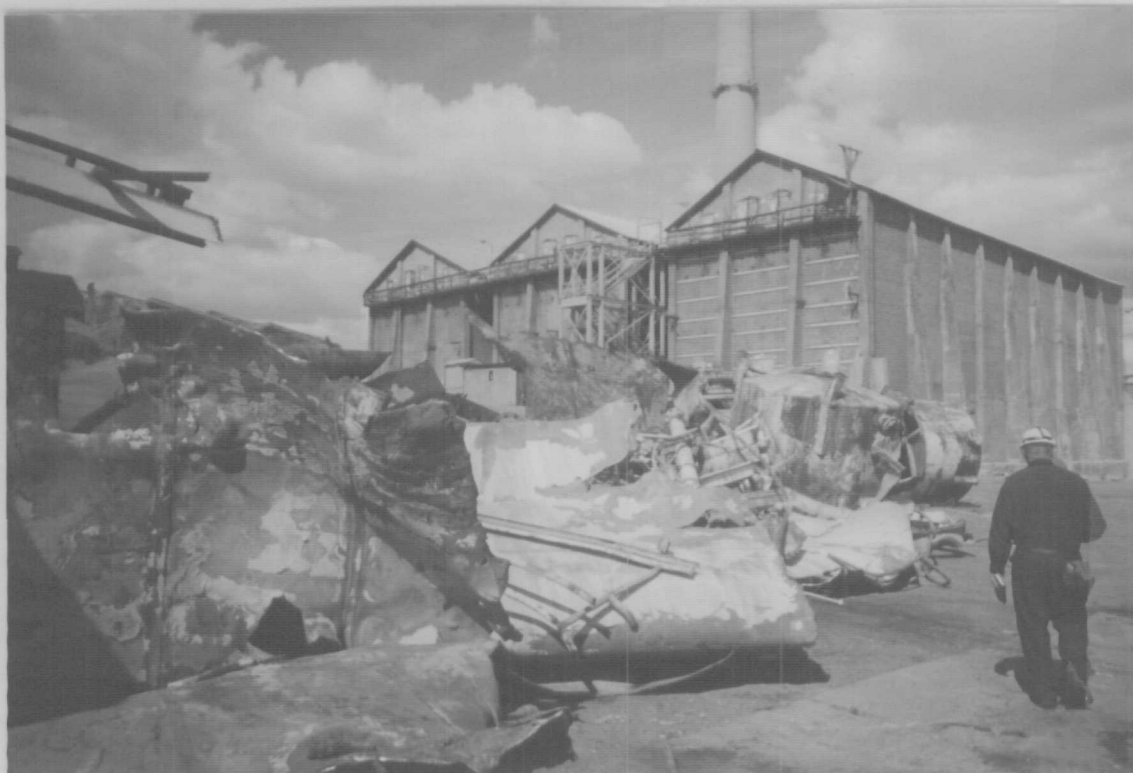
Roll 1, Photo 13; Facility: ASARCO East Helena Smelter; Subject: Demolition Scrap;
Photographer: Linda Jacobson; Date: August 31, 2006

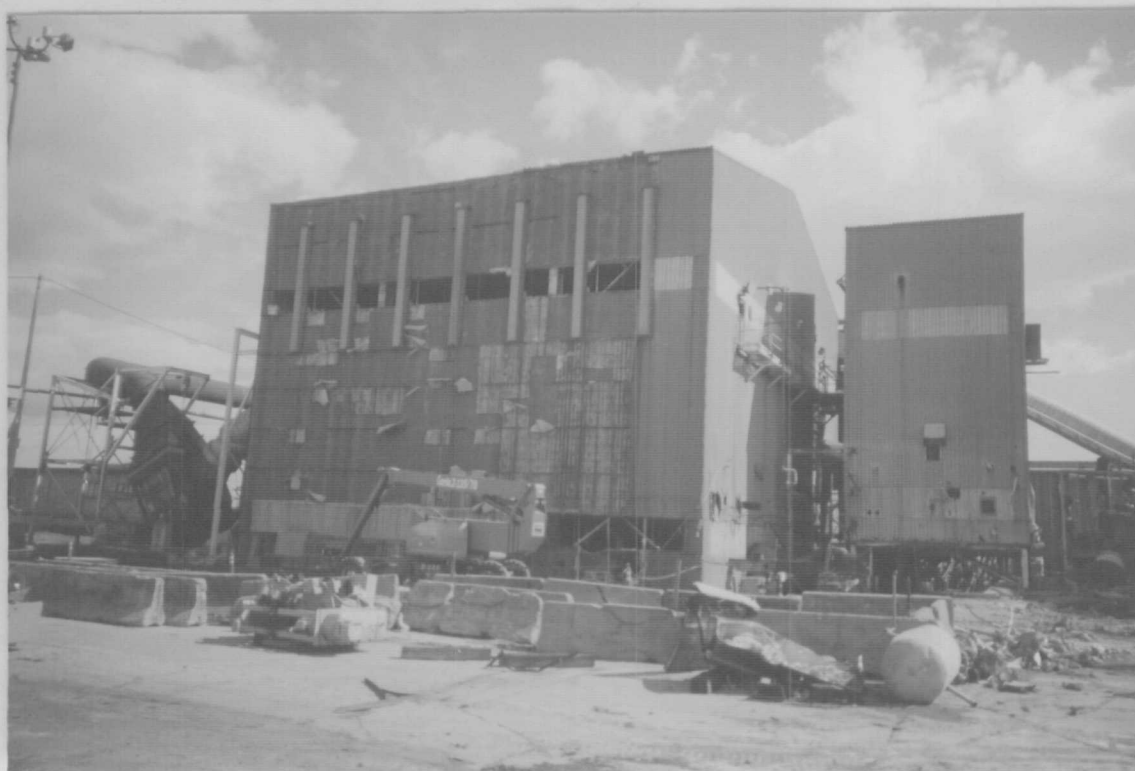
Roll 1, Photo 14; Facility: ASARCO East Helena Smelter; Subject: Hot Cottrell Building;
Photographer: Linda Jacobson; Date: August 31, 2006

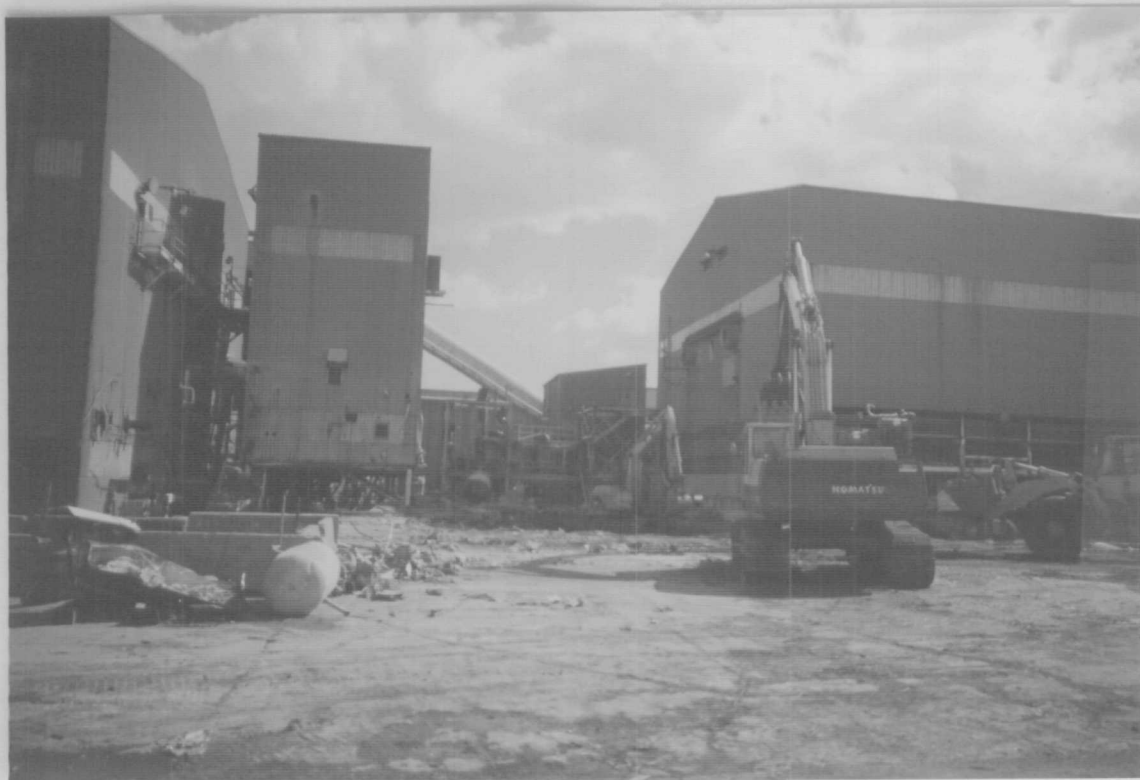
Roll 1, Photo 15; Facility: ASARCO East Helena Smelter; Subject: Demolition Equipment;
Photographer: Linda Jacobson; Date: August 31, 2006

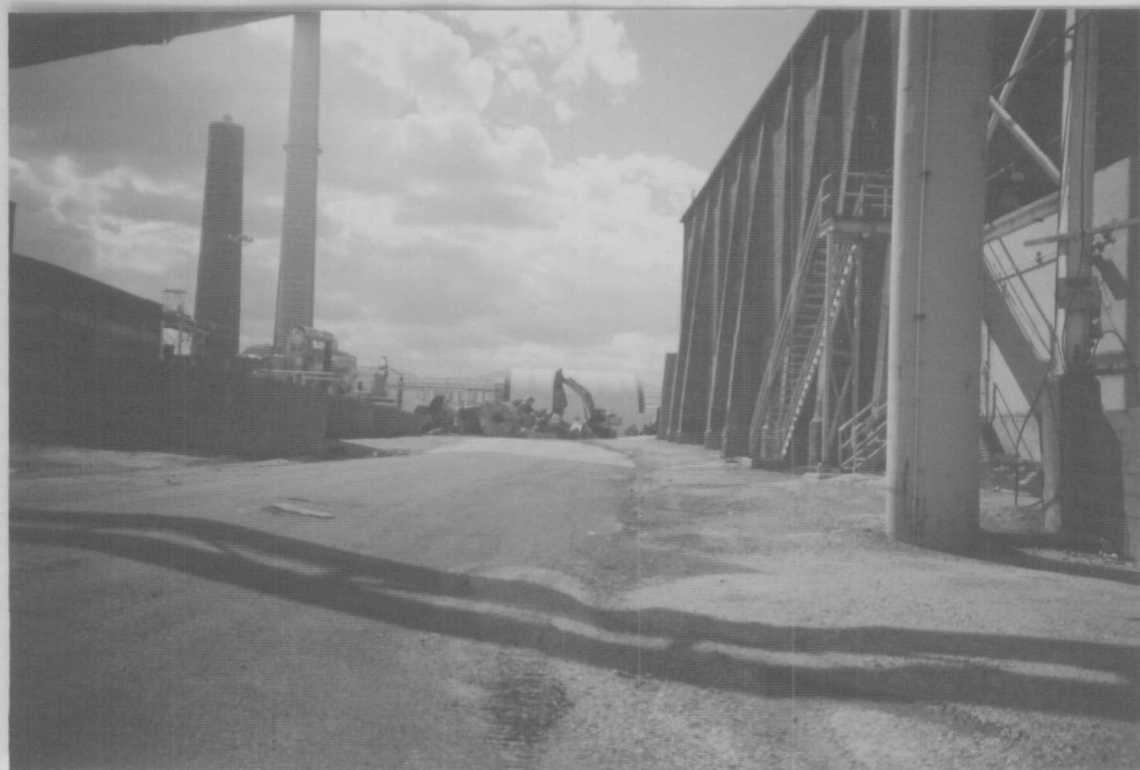
Roll 1, Photo 16; Facility: ASARCO East Helena Smelter; Subject: Demolition Proceeding;
Photographer: Linda Jacobson; Date: August 31, 2006

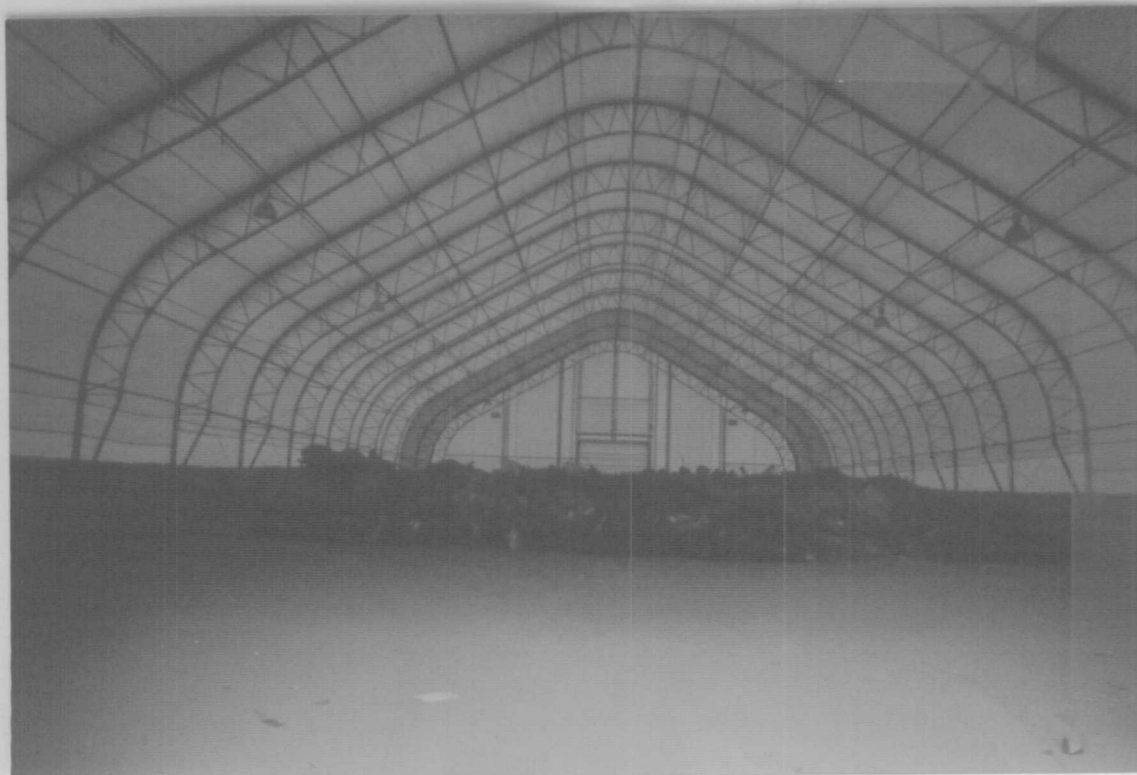
Roll 1, Photo 17; Facility: ASARCO East Helena Smelter; Subject: Waste Inside Bailey Building; Photographer: Linda Jacobson; Date: August 31, 2006

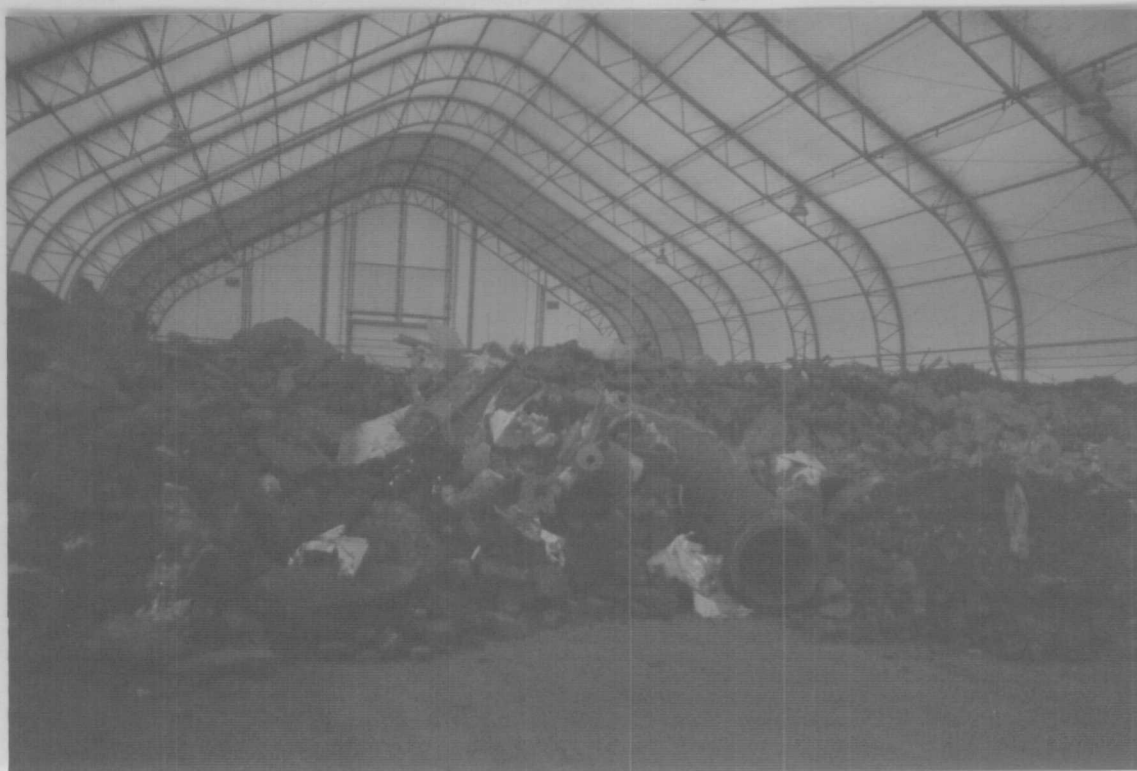
Roll 1, Photo 18: Facility: ASARCO East Helena Smelter; Subject: Waste Storage Inside Bailey Building; Photographer: Linda Jacobson; Date: August 31, 2006

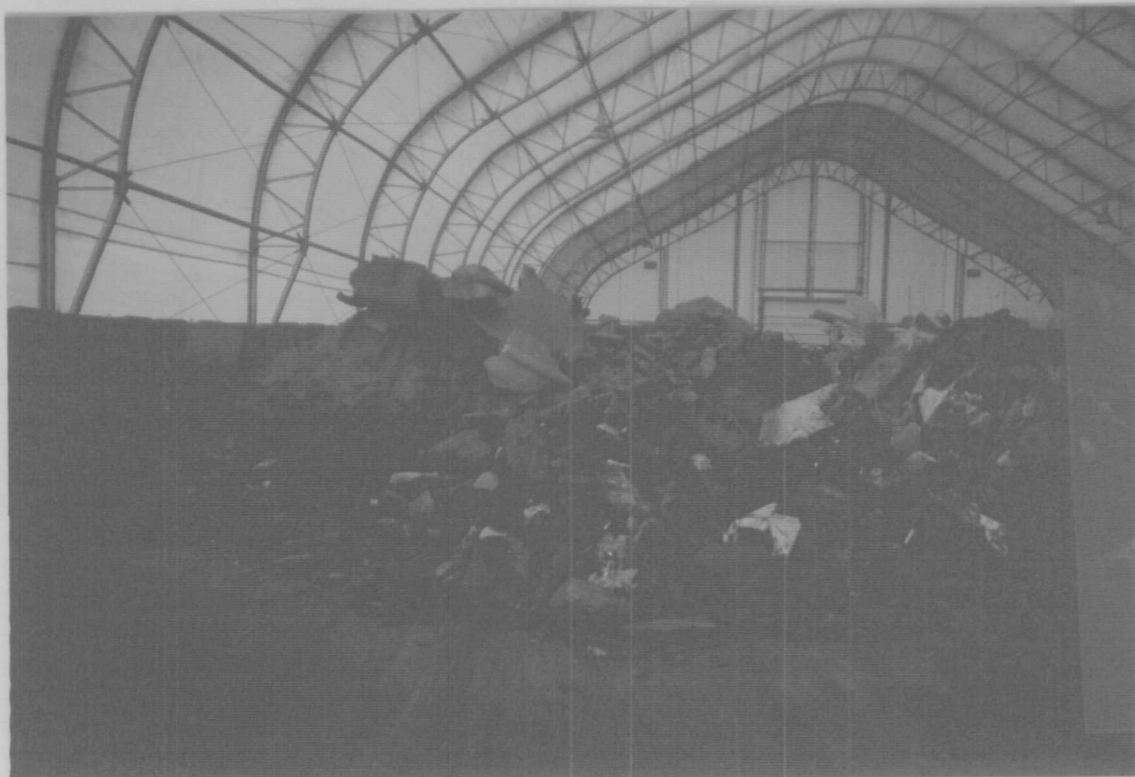
Roll 1, Photo 19; Facility: ASARCO East Helena Smelter; Subject: Waste Storage Inside Bailey Building; Photographer: Linda Jacobson; Date: August 31, 2006

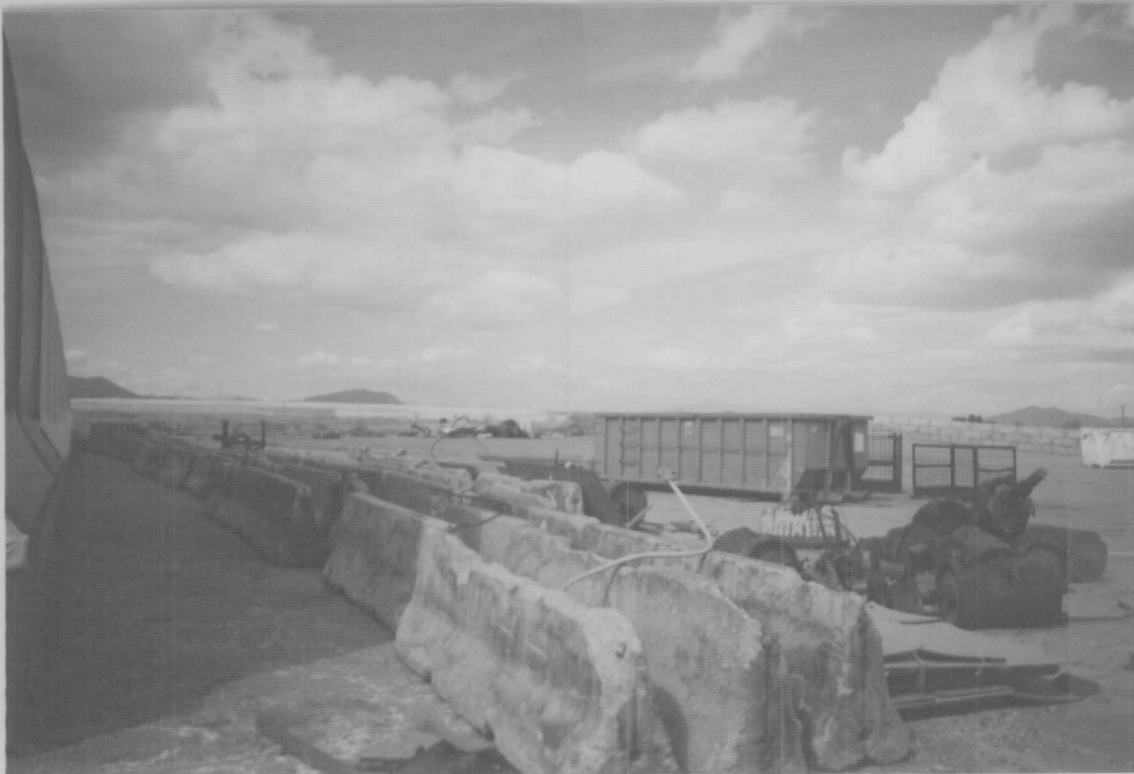
Roll 1, Photo 21; Facility: ASARCO East Helena Smelter; Subject: Lay Down Area for Recyclable Materials; Photographer: Linda Jacobson; Date: August 31, 2006

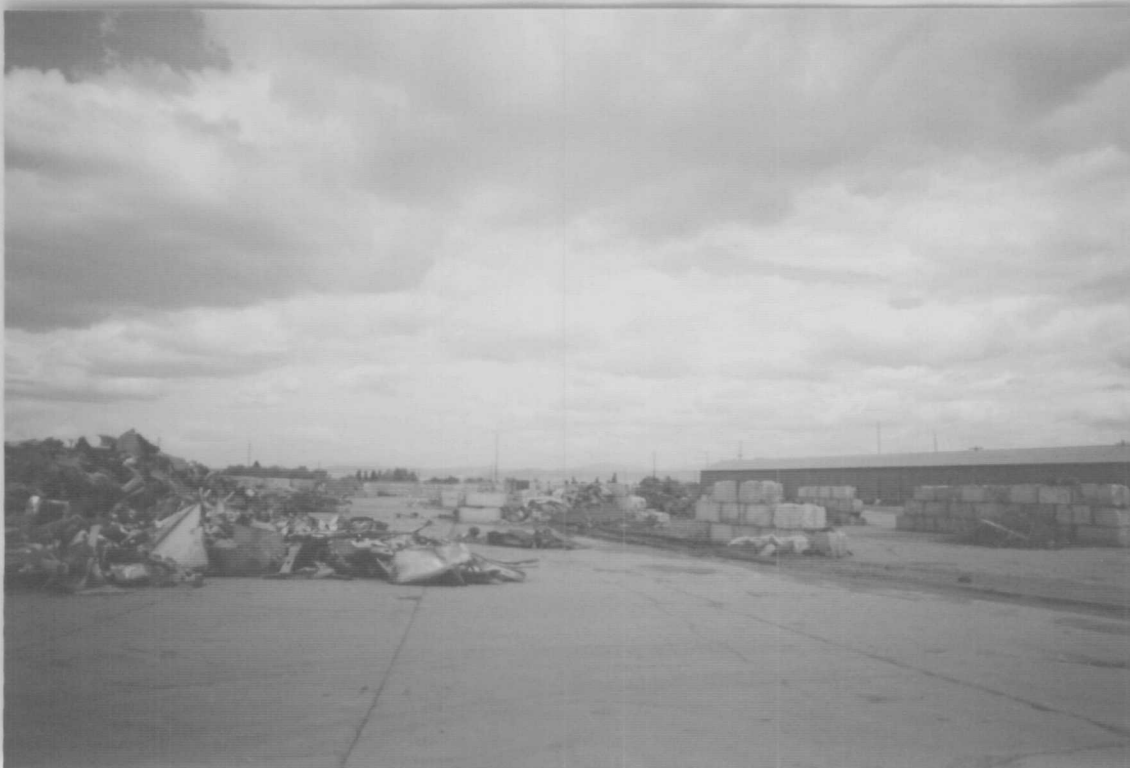
Roll 1, Photo 22; Facility: ASARCO East Helena Smelter; Subject: Demolition Scrap Material; Photographer: Linda Jacobson; Date: August 31, 2006

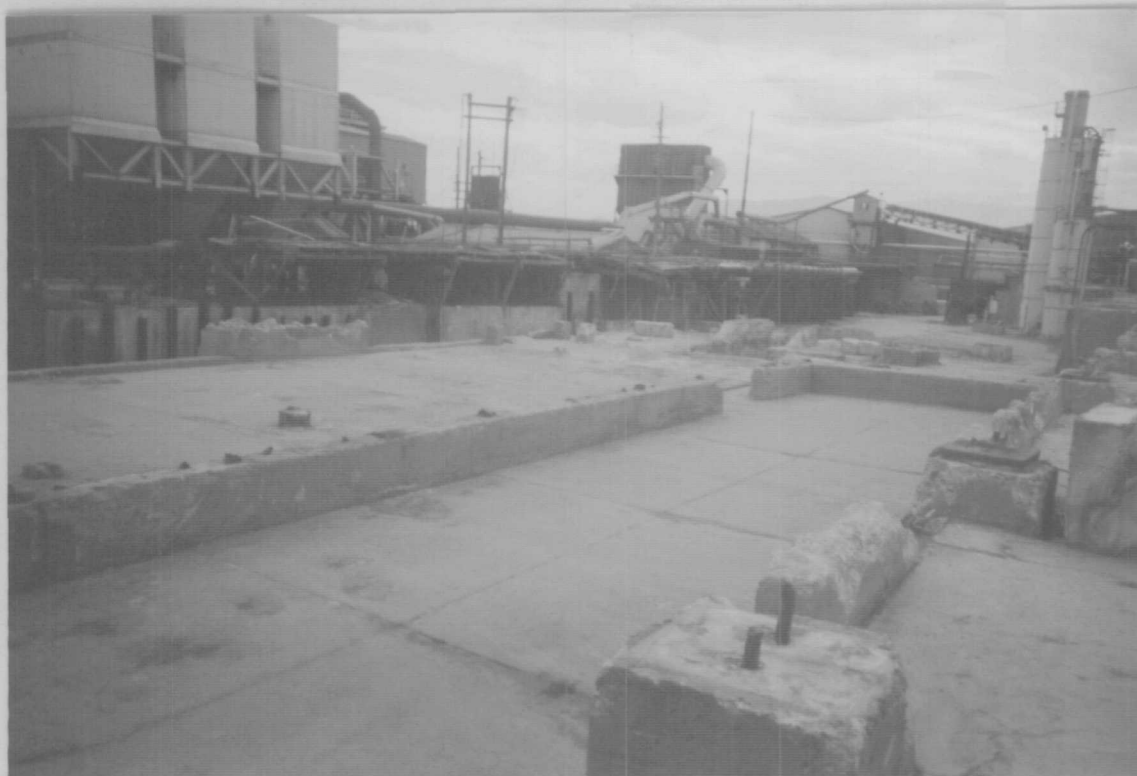
Roll 1, Photo 23; Facility: ASARCO East Helena Smelter; Subject: Former Sinter Plant Foundation; Photographer: Linda Jacobson; Date: August 31, 2006

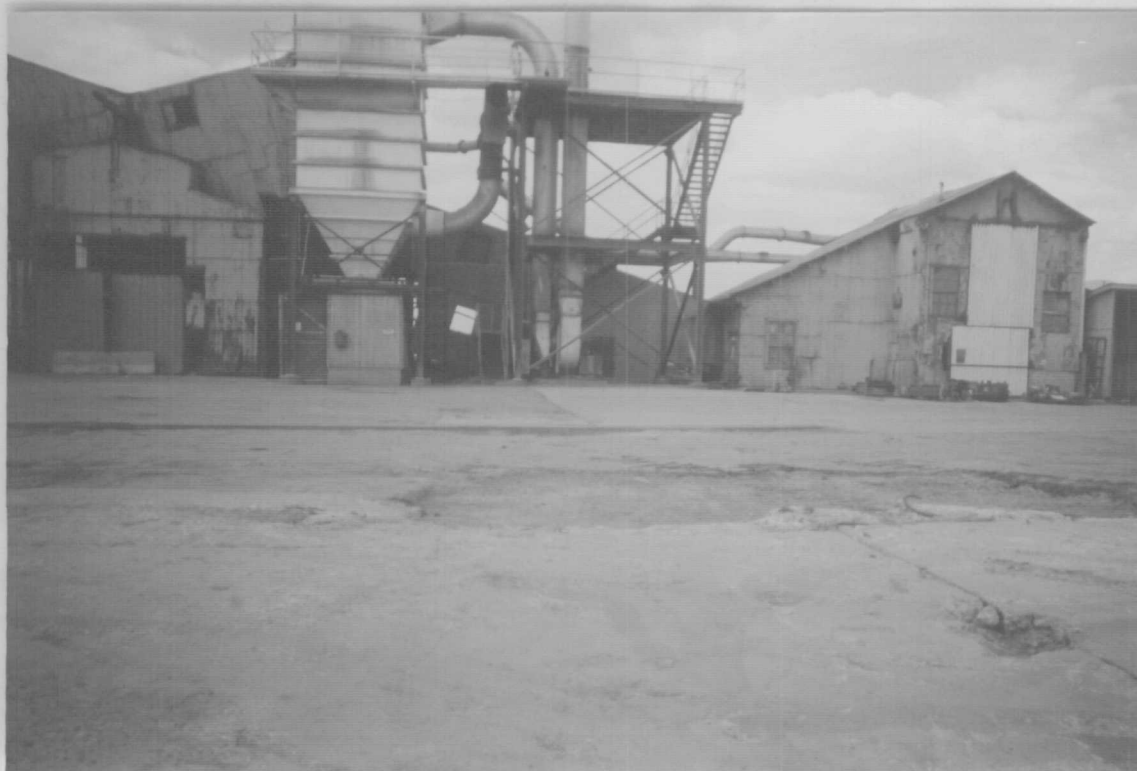
Roll 1, Photo 24; Facility: ASARCO East Helena Smelter; Subject: Former Sinter Plant Foundation; Photographer: Linda Jacobson; Date: August 31, 2006

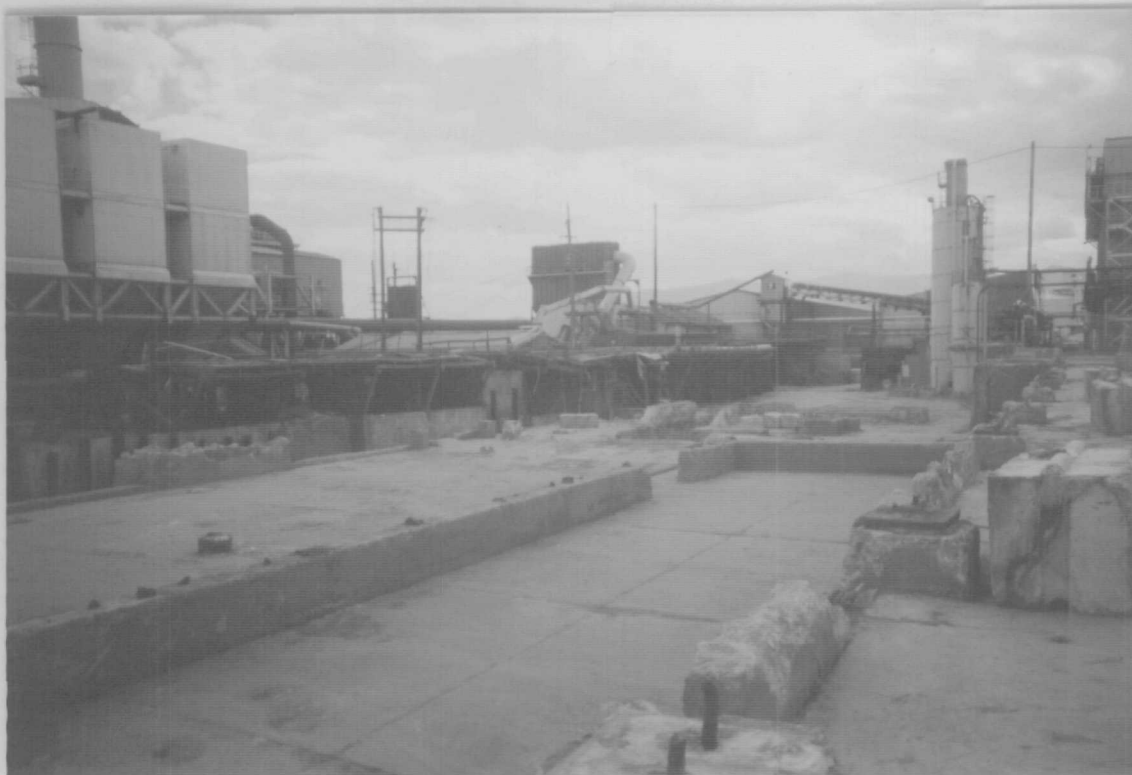
Roll 1, Photo 25; Facility: ASARCO East Helena Smelter; Subject: Former Sinter Plant Foundation; Photographer: Linda Jacobson; Date: August 31, 2006

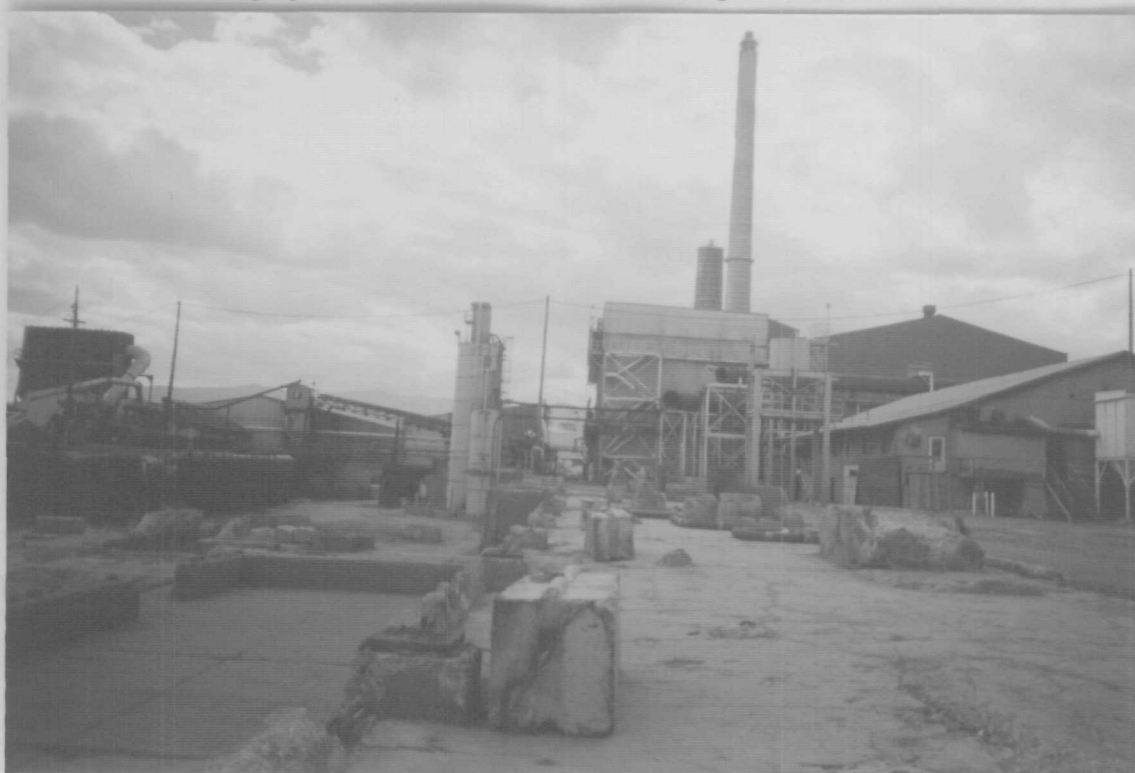
Roll 1, Photo 26; Facility: ASARCO East Helena Smelter; Subject: Former Sinter Plant Foundation; Photographer: Linda Jacobson; Date: August 31, 2006

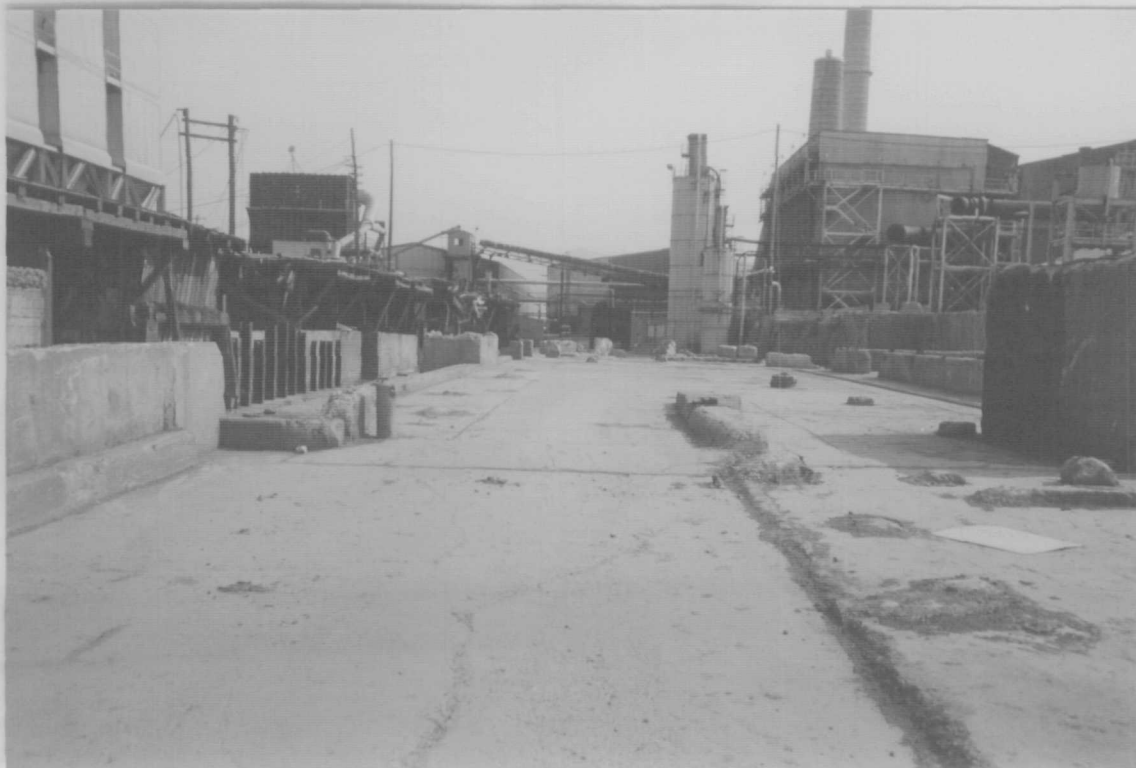
A walkthrough was conducted of a portion of the plant to allow photographic documentation of some of the building demolition activities. Photos were taken at the Sinter Plant including the Larry Pit, exposed soils, foundations, and the drain sump. Mr. Nickel indicated that the exposed soils will be sampled for the full suite of metals and covered with a temporary cap. The sump drain, the elevator, and other low lying spots will be filled in with slag.

Roll 2, Photo 4; Facility: ASARCO East Helena Smelter; Subject: Foundation of Former Sinter Plant; Photographer: Linda Jacobson; Date: September 8, 2006

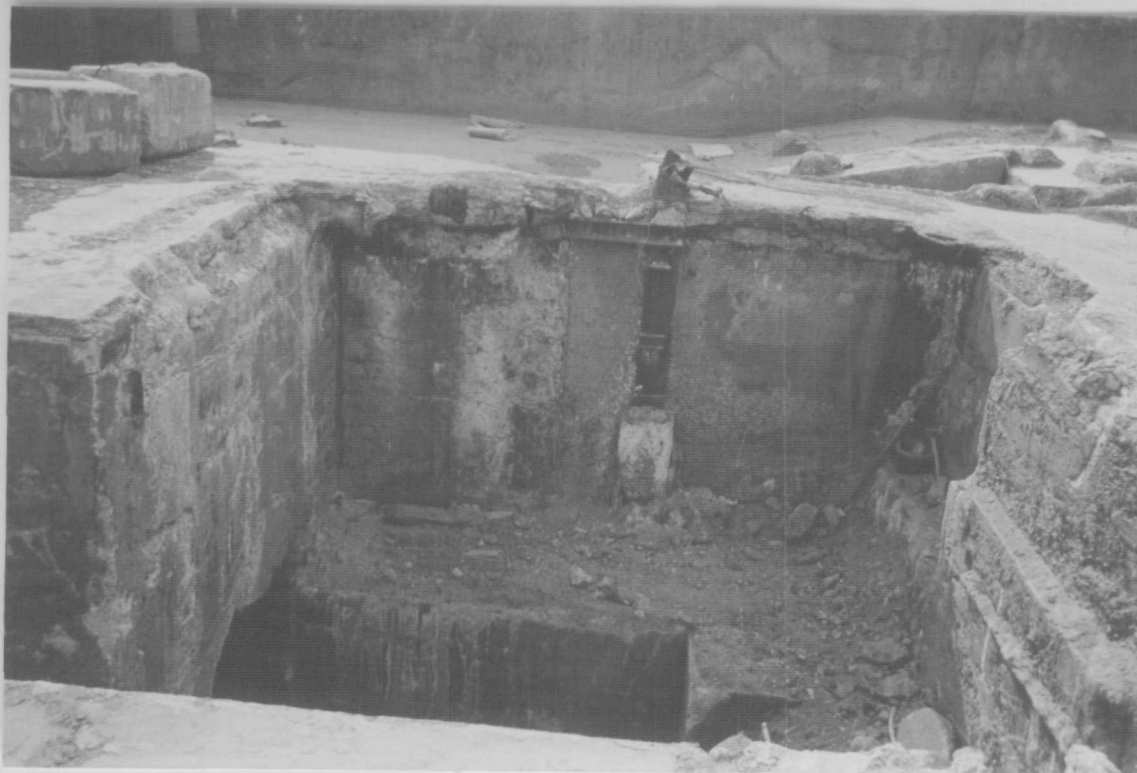
Roll 2, Photo 8; Facility: ASARCO East Helena Smelter; Subject: Condition of Sinter Plant Footprint; Photographer: Linda Jacobson; Date: September 8, 2006
